Dissolving Tank Beam Repair

Halsey, Oregon

Client:
Cascade Pacific Pulp

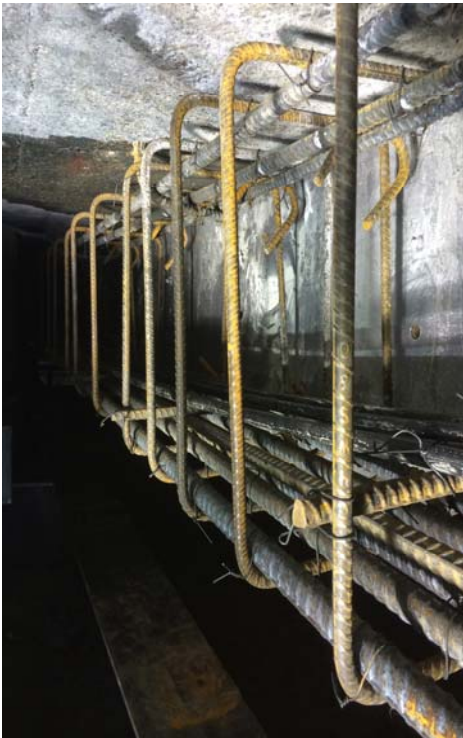
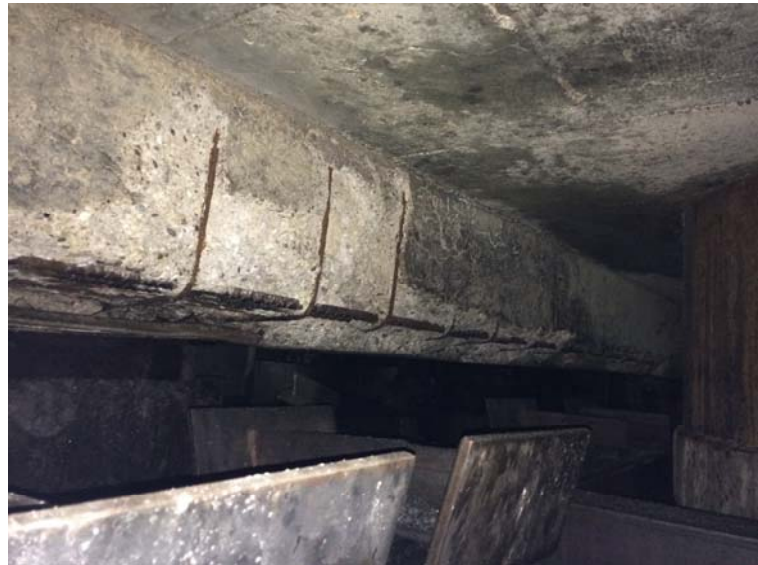
As part of concrete investigations, our office discovered that a concrete beam supporting the floor over the dissolving tank was severely damaged. After review of the process and location, sulfate attack and physical damage from explosion ports were suspected as likely culprits. Dust samples were taken and analyzed to confirm our suspicion. With the beam tight to smelt spouts on the north side, 18" from the stack on the south side and 8" above the dissolving tank framing, this was going to prove to be a difficult place to work. The project would have to be implemented during a 7-day shutdown with other activities happening within the tank below and on the floor above. After analysis of multiple options, it was decided to add a second beam adjacent to the existing beam. This beam was designed to carry 100% of the loads and was post-tensioned to move existing loads out of the old beam and into the new beam. The project was implemented on time and under budget while not impacting adjacent shutdown activities.
