# Industrial Roof

Oregon

**STRUCTURAL FORENSICS**

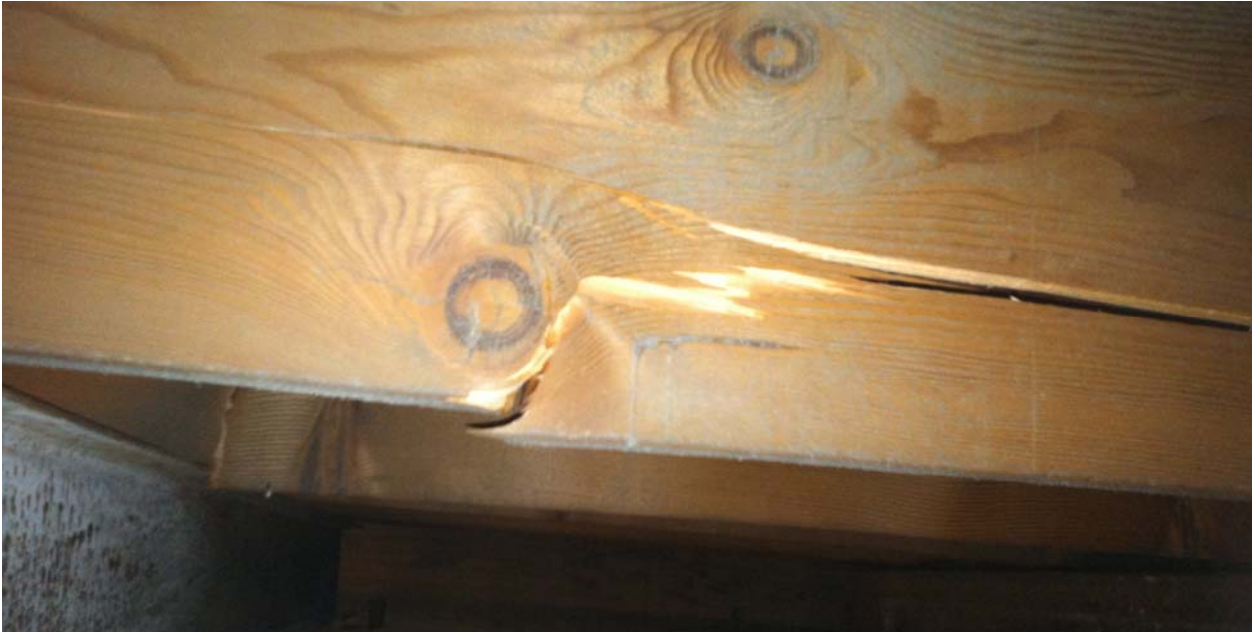
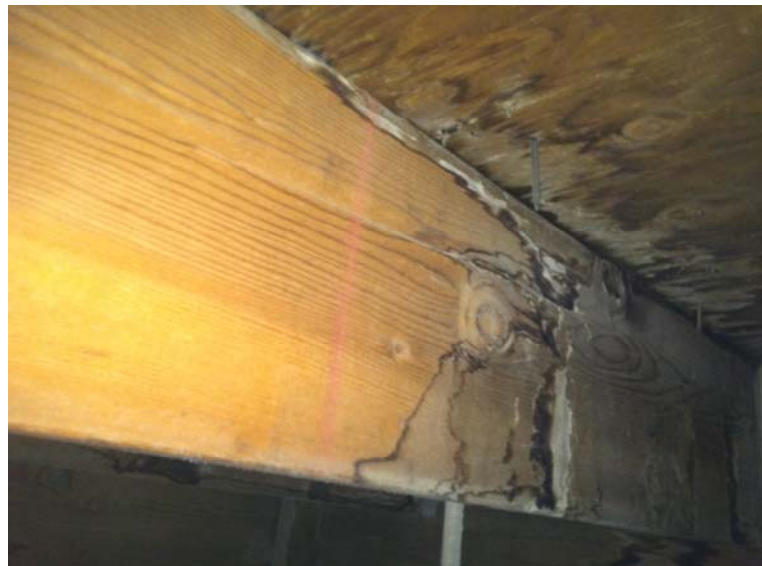
Extensive roof damage was discovered within an industrial plant's warehouse building. Our office was brought in to determine the extent of damage, cause of the damage and to provide repair solutions. After a thorough investigation, our engineers identified the extent of the damage and determined the cause to be overloading of the roof due to rain ponding. Primary roof drains were clogged by debris related to the industrial process and no secondary drains were provided as required by the building code. Ponding of rainwater led to excessive deflections of structural framing members, which led to an increased depth of ponding. Ultimately, the rainwater overloaded roof joists and led to a failure of the framing system.
