Historic Building Façade Failure

Corvallis, Oregon

STRUCTURAL FORENSICS

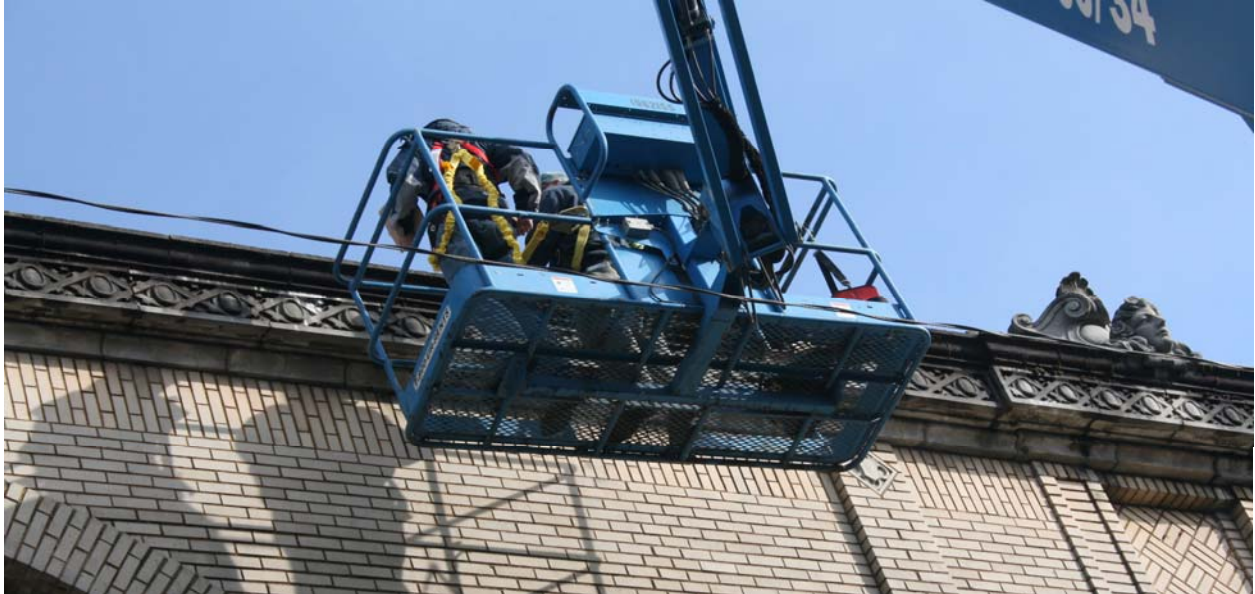
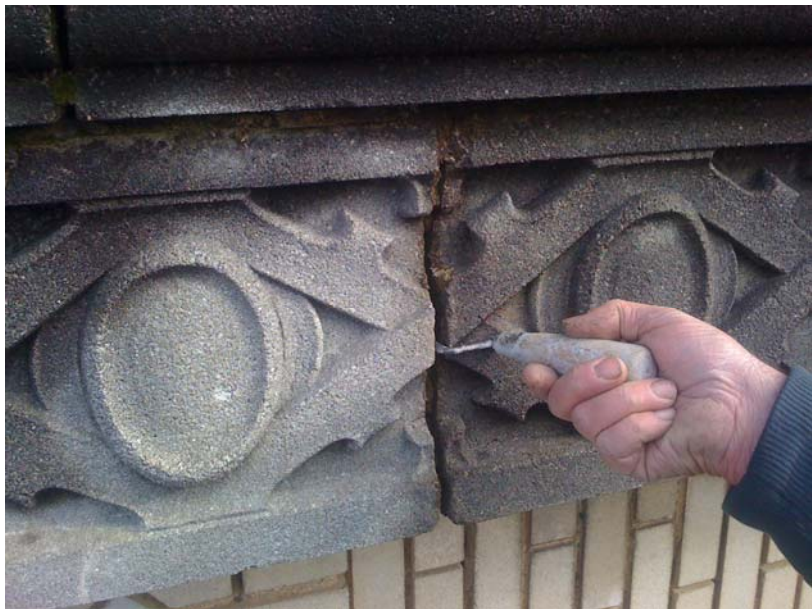
After a frieze block weighing around 125# fell from a height of about 40' above the sidewalk, our office was brought in to determine the cause of the failure and to inspect the remainder of the façade for potential future failures. It was determined that the most likely cause of failure was water intrusion due to deterioration of grout lines. After a thorough investigation, numerous other locations of deterioration were identified and reported. In the end, the stakeholders worked closely together to fix the failed element and to provide necessary maintenance and repairs to the remainder of the facade
