Mixer Deck Replacement

Halsey, OR

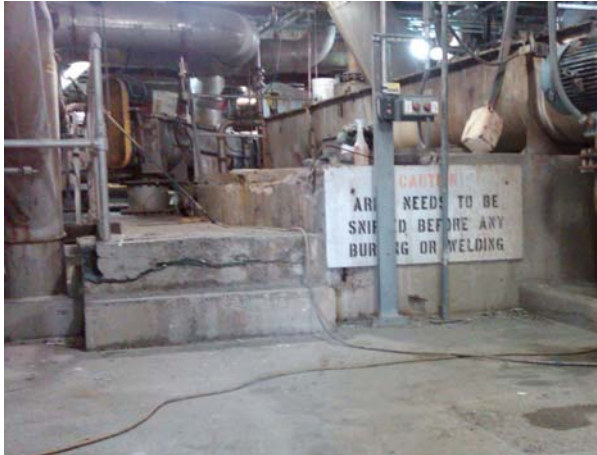
BEFORE PICTURE

Chemical exposure, vibratory loads and 40+ years of non-stop use, have combined to deteriorate concrete at this industrial plant.

The 3rd Floor Mixer Deck was no exception to this. Concrete was severely deteriorated to the point of disrepair. Pillar Consulting Group was asked to provide a design for a new deck that could be implemented during the annual shutdown.

Pillar provided an efficient design capable of being partially installed with the concrete in place. This provided support for concrete demolition and temporary support for equipment. The contractor was able to start demolition early since the equipment did not have to be removed and was able to successfully complete the project during the short shutdown window.

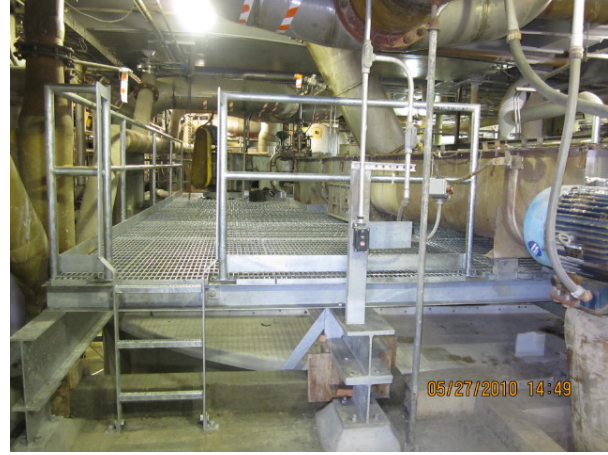
AFTER PICTURE
