Wastequip Crane Retrofit

Albany, Oregon

Building strengthening for bridge crane installation

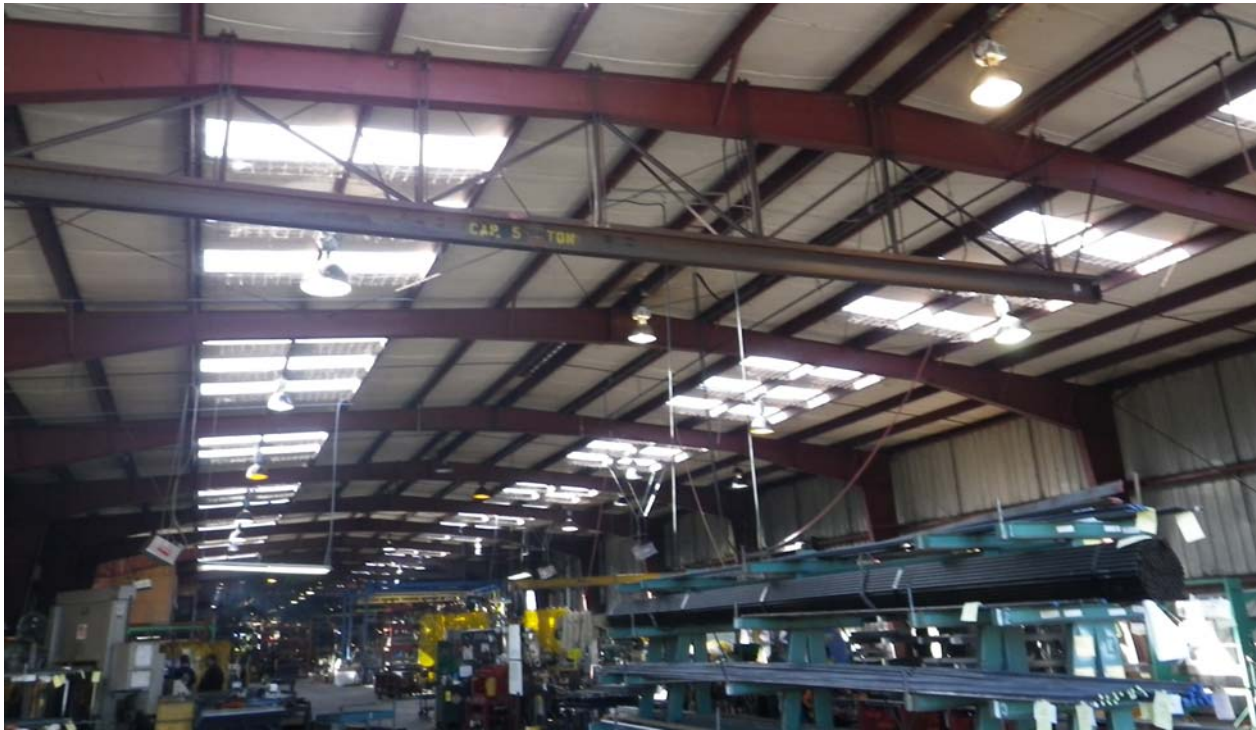
After installing a new bridge crane, it was discovered that the crane was causing excessive deflection in this pre-engineered metal building, which was leading to roof leaks.

Pillar Consulting group came in and retrofitted the existing building to handle the new loads. Two methods were used to strengthen the building and reduce deflections. At locations where work flow allowed, column were added at the center of the building to reduce frame loads. At locations where columns were not feasible, the frames were strengthened for the new loads.
